Contract #: 04-0120F4Cty: SF/ALA Rte: 80 PM: 13.2/13.9File #: 82.28**WELDING INSPECTION REPORT****Resident Engineer:**Siegenthaler, Peter**Address:** 333 Burma Road**City:** Oakland, CA 94607**Report No:** WIR-026221**Date Inspected:** 26-Aug-2011**Project Name:** SAS Superstructure**OSM Arrival Time:** 600**Prime Contractor:** American Bridge/Fluor Enterprises, a JV**OSM Departure Time:** 1430**Contractor:** Westmont Industries**Location:** Santa Fe Springs, CA**CWI Name:** Ruben Dominguez**CWI Present:** Yes No**Inspected CWI report:** Yes No N/A**Rod Oven in Use:** Yes No N/A**Electrode to specification:** Yes No N/A**Weld Procedures Followed:** Yes No N/A**Qualified Welders:** Yes No N/A**Verified Joint Fit-up:** Yes No N/A**Approved Drawings:** Yes No N/A**Approved WPS:** Yes No N/A**Delayed / Cancelled:** Yes No N/A**Bridge No:** 34-0006 L & R**Component:** Maintenance Travelers**Summary of Items Observed:**

## WELDING INSPECTION REPORT

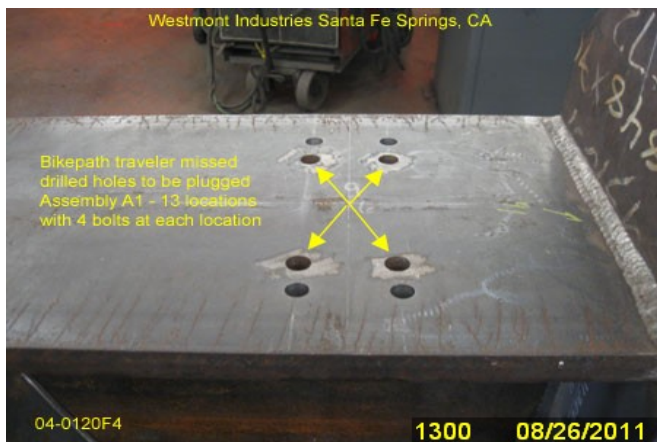
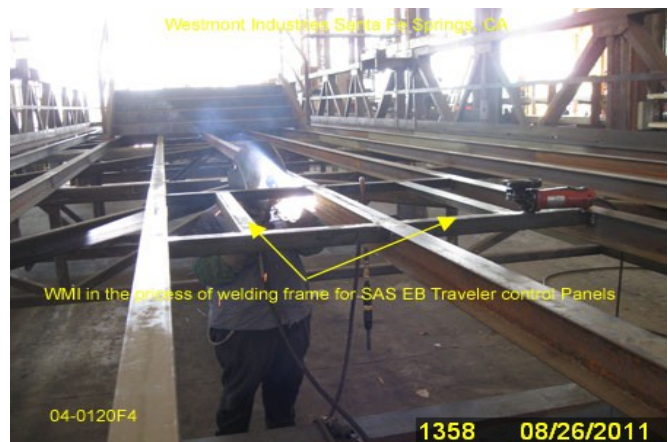
This QA Inspector performed measurement on dry film thickness (DFT) with Type 2 (magnetic gage), DFT's thickness reading of the top coat on trolley link assemblies top coated using the Sherman Williams Polysiloxane XLE-80 Epoxy Siloxane on 08-25-11 are an average of three (3) thickness reading are as follows 10.1 mils, 11.6 mils, 9.7 mils, 12.9 mils, 11.6 mils, 9.6 mils, 11.1 mils, 11.5 mils, and 10.4 mils. QA Inspector was informed by Mr. Nunez that RPI will be touching up areas that have dry film thickness reading lower than 8.5 mils using a paint roller. Note: RPI Coating completed top coating on the Traveler Trolley Links and Suspension Arms on this date.
